SAFETY DEPARTMENT

Guidelines for checking FHR devices following a severe accident – informative note with no regulatory value

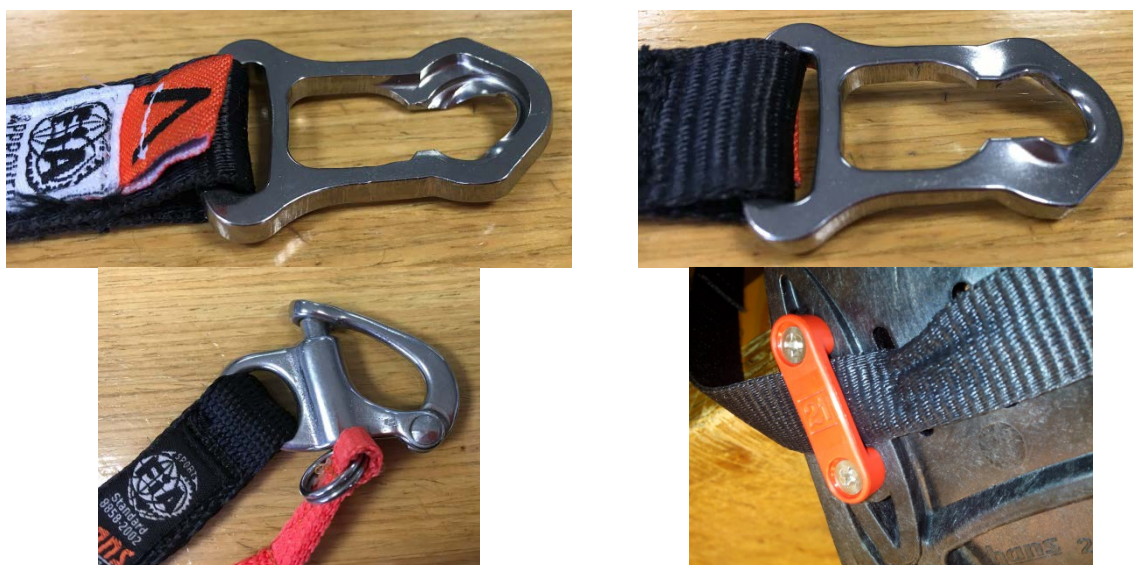
1. Whether the FHR tether or FHR end fitting is damaged, as shown in Figure 1.

Figure 1 – Deformed end fitting (top right and left, and bottom left), and stretched FHR tether (bottom right)

If any sign of damage as mentioned in points 1 to 3 above is identified, the FHR device is to be sent to the manufacturer so that non-destructive tests can be performed in order to check the structural integrity of the part.

Even if there is NO damage as mentioned in points 1 to 3 above, the FHR tether should be replaced, because the FHR tether may have been stretched and consequently it may not work properly in the event of a second severe accident.

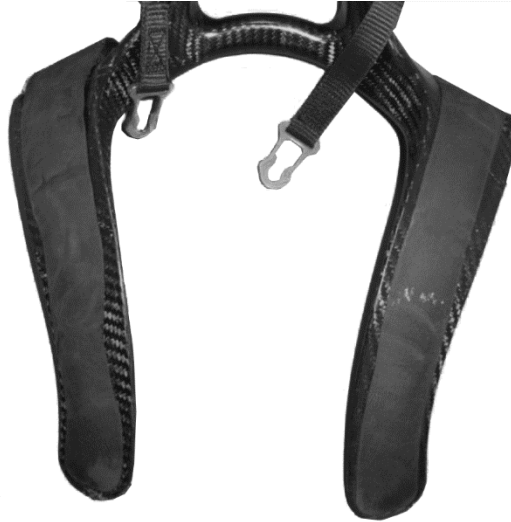
2. Whether there are any signs of wear or friction on the FHR surface in contact with the shoulder belts, as shown in Figure 2.

Figure 2 – Signs of wear on the rubber surface

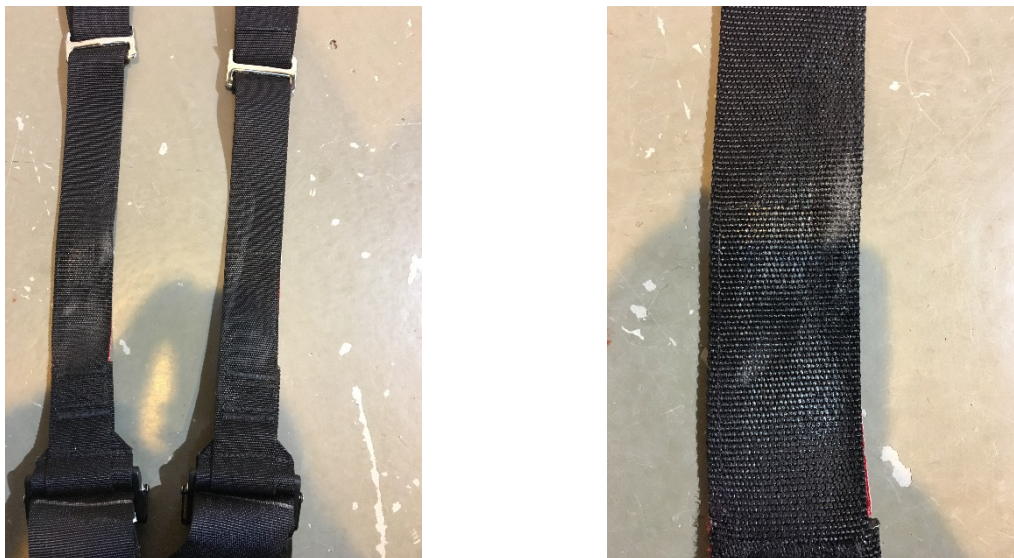
3. Whether the shoulder belt has been stretched, as shown in Figure 3.

Figure 3 – Shoulder belts stretched after a severe crash

The safety harness shall be replaced with a new one, as webbing that has been stretched will not perform as desired during a second accident.
